### FIELD FIX FOR SKIPPING TEETH ON THROUGH-FRAME SLIDEOUTS

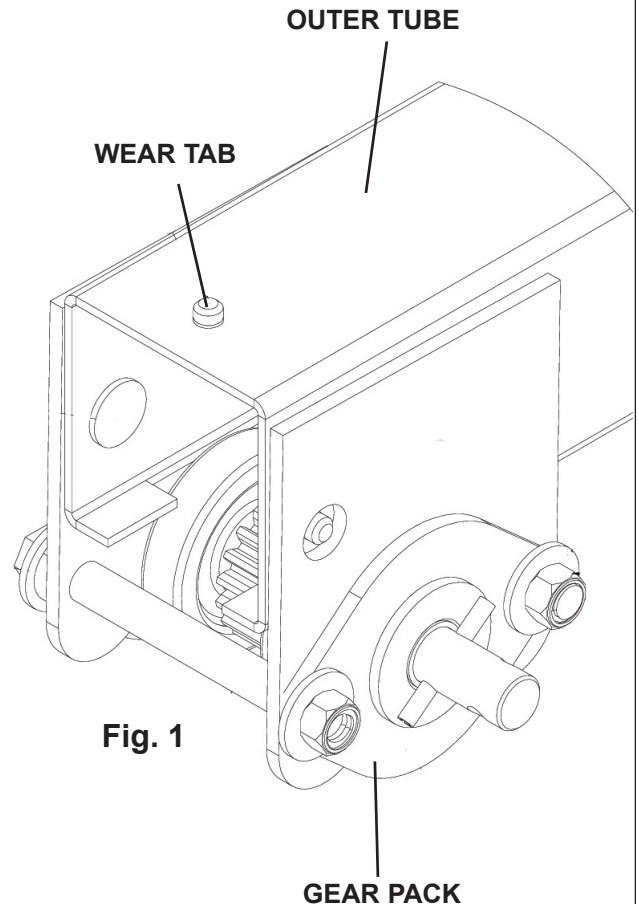
In the event that the gear pack binds, the INNER TUBE of the slideout may be pushed upward creating a condition the crowns or bends the top of the OUTER TUBE creating enough space that will allow the gear pack to periodically skip teeth. The following field fix remedies the occurrence:

1. Extend slideout room.
2. Locate the end of the slideout assembly where the gear pack is fastened. **Fig. 1**
3. Inspect top of OUTER TUBE for crowning (top center of tube is higher than top sides). **Fig. 1a**

4. If OUTER TUBE is crowned, tap portion of the WEAR TAB protruding from the top of the OUTER TUBE, down, be careful not to remove the WEAR TAB. **Fig. 2**

5. Take a 5/16" flat washer, **Fig. 3**, and remove a notch equal to the diameter of the hole, **Fig. 4**.
6. Slide the notched washer into the gap created when the WEAR TAB was tapped out. **Fig. 5**.

7. Slide a pry bar or screwdriver under the cap of the WEAR TAB and push it up to seat it properly into place.
8. Reset timing on the drive (actuator) side.
