by Gary Bunzer, the RV Doctor

RV Absorption Refrigeration

The Technology of Refurbishing a Cooling Unit

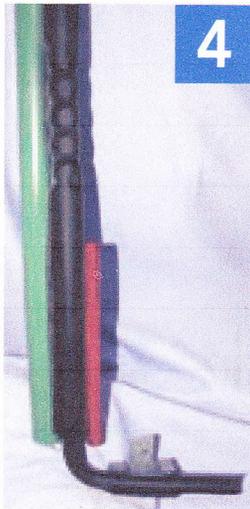
4 A cutaway view of the boiler section, (black tubing). The green section is the flue pipe that is positioned directly over the propane burner flame. The red portion is the sleeve or pocket into which the electrical heating element slips. On three-way refrigerators there will be two separate heater pockets.

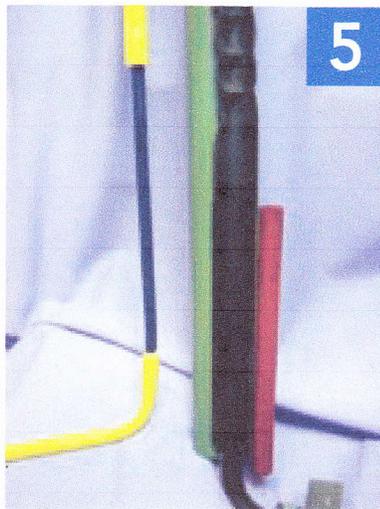
5 The percolator tube (blue/yellow tube) will be positioned inside the boiler tube. This is the tube that becomes plugged with the crystallized chromate when the refrigerator is chronically operated off level or when a leak develops; both conditions will overheat the boiler section.

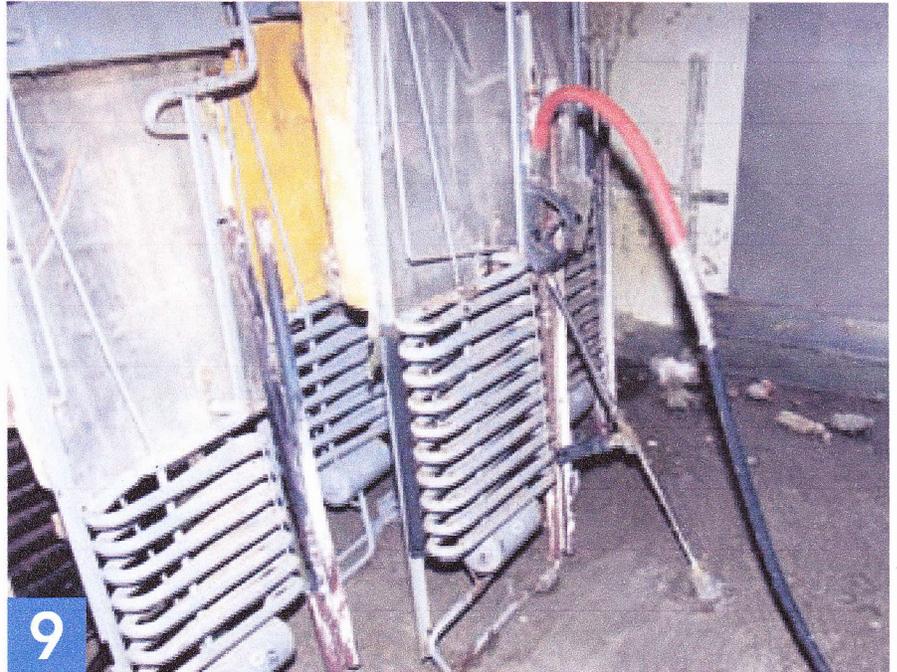
11 As an example, shown to the right, this tiny rupture would not have been visible if the core had not been sandblasted first.

Next, each core is sandblasted so a detailed inspection can be better facilitated. The technician must be able to view every inch of tubing so all rust, scale, paint and dirt must first be removed, especially in the area usually surrounded by the foam pack.
